TWO-DAY TURNAROUND

Story and photos by
PA3 Lauren Downs, First District

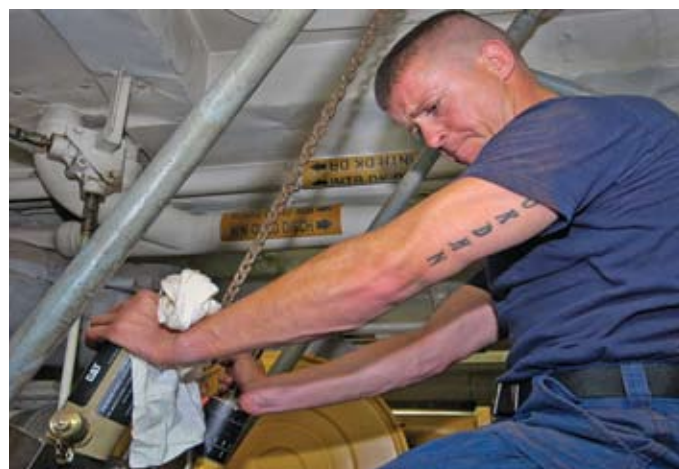
▲ **MR. FIX-IT** MK2 Matthew Husler guides a cylinder liner down the ladder to the Juniper's engine room.

The engineers and MAT personnel struggled to disassemble the cylinder head until 11 p.m. Sept. 27. After a 16-hour day, they returned at 7 a.m. the following day to continue the work. Finally at mid-morning, they found the source of the problem. The O-ring on the

top of the cylinder liner was wearing away causing the engine to overheat, said MKC Micha Wisniewski, an engineer aboard the Juniper.

Luckily the Juniper's engineers were prepared. They had another O-ring in their warehouse and began to replace the worn-out one that day.

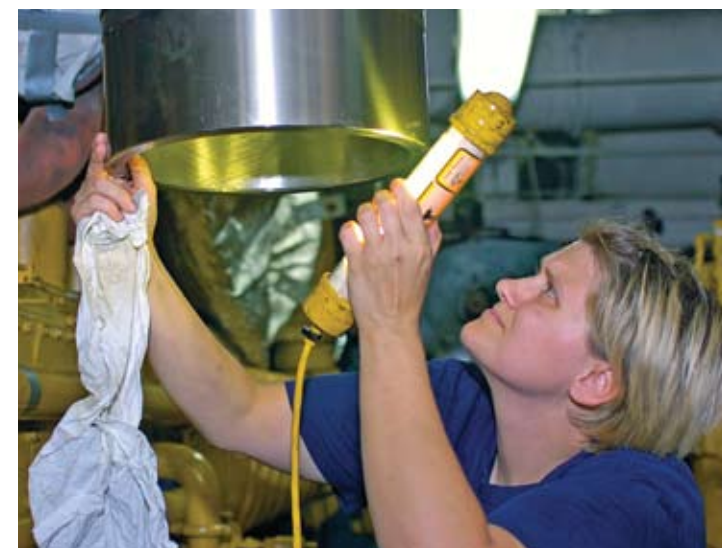
▲ **INSPECTOR GADGET** MKC Micha Wisniewski inspects a cylinder liner before sliding it into the Juniper's engine.

The engineers worked a 12-hour day Sept. 25 to reassemble the engine. As a result, the Juniper was ready to leave again the following day. The "black hull" pulled into Halifax about 4 a.m. Sept. 28, just in the nick of time.
